PRACTICAL GUIDE

# Dry Rot in Buildings: What Is Dry Rot and Why Should I Be Concerned About It?

July 2022

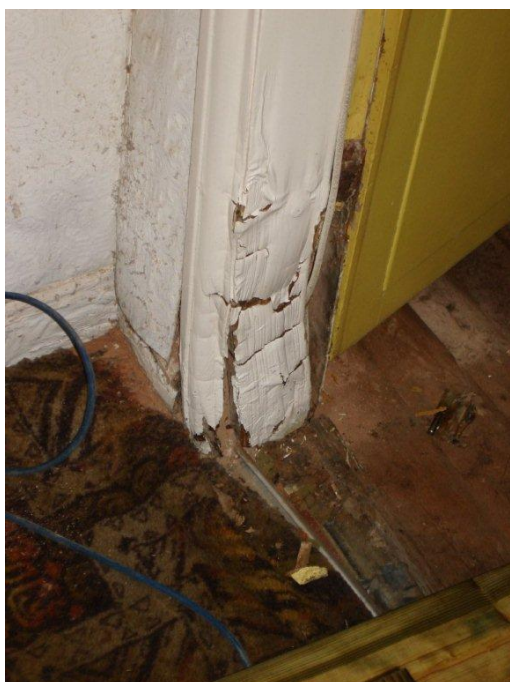
Figure 1

Dry rot often develops in areas out of sight, such as behind door frames or skirting boards. One of the first visible signs of dry rot can be the warping or distortion of the surface of timbers as the timber is attacked from behind.

- On painted timber surfaces, such as skirtings, the paintwork may remain intact but the surface behind becomes wavy, warped and deformed (appendix figure 1).

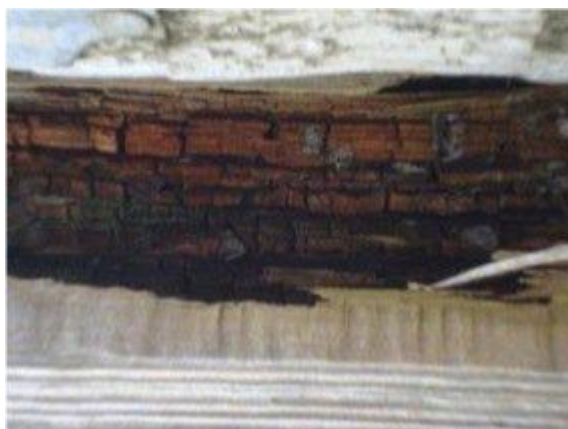
Figure 2

Cuboidal cracking of the wood into brick-shaped pieces with cracks both along the grain and across the grain is characteristic of dry rot, although some wet rot can have a similar appearance. The wood appears as if charred but not as darkly coloured.

Dry rot digests the part of the wood which gives it strength and stiffness. In the advanced stages of decay caused by dry rot, the timber will crumble readily into dry powder. The timber no longer has the fresh or resinous smell of sound wood. The wood will often shrink and become light and will split. Characteristic of splitting through dry rot are deep longitudinal and cross cracks which form a cuboidal appearance of cracking (appendix figures 2 & 5). However, some wet rot fungi can produce a very similar cuboidal cracking.

- Splitting, shrinking, cracking of wood, particularly cuboidal cracking, although some wet rots also exhibit cuboidal cracking (appendix figure 2)
- Wood becomes soft, crumbly and changes colour to brown. Blunt instruments can readily be pushed into the surface or body of the wood.

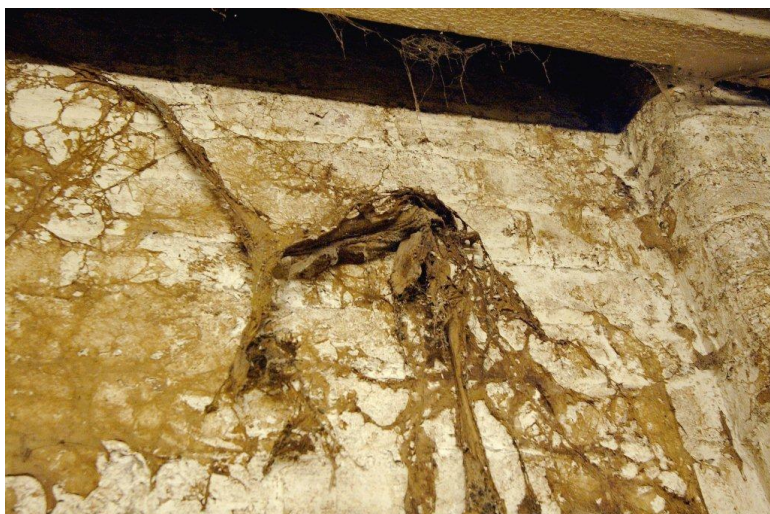
Figure 3

Dry rot mycelium and strands extend across or through inorganic materials such as brickwork in search of timber as a food source.

As the mycelium advances further from the initial outbreak, branching strands are formed behind it. These can be 2 to 8mm diameter and grey or white in colour (appendix figure 3). The strands transport the nutrients from the original food source to the advancing edge of the mycelium. This enables the fungus to traverse over in-organic materials from which it can extract no nutrients. The mycelium can therefore traverse across solid floors, through brickwork and stonework and particularly through hidden voids. Extensive spreading can take place behind plaster and similar finishes, without being visually detected by users of the building (appendix figure 4).

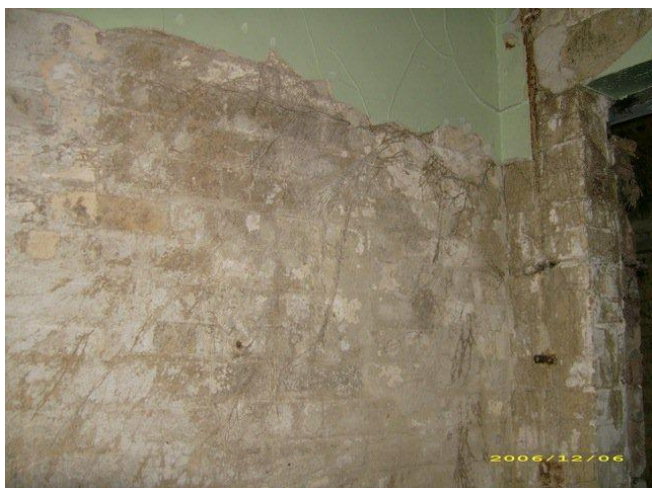
Figure 4

Dry rot strands often travel in hidden areas, such as behind plaster. It is necessary to remove the plaster to ascertain the full extent of the outbreak

- Floor boards can dip into corners or edges
- Mycelium and strands can be found to be spreading behind concealed surfaces, such as plaster, wall panelling etc (appendix figure 4).

Once what is considered to be the full extent of the outbreak has been determined, finishes such as plaster etc must be removed for at least 1m beyond the furthest visible extent (appendix figure 4); firstly, to ensure the full extent has been determined and secondly to facilitate treatment in the area surrounding the outbreak.

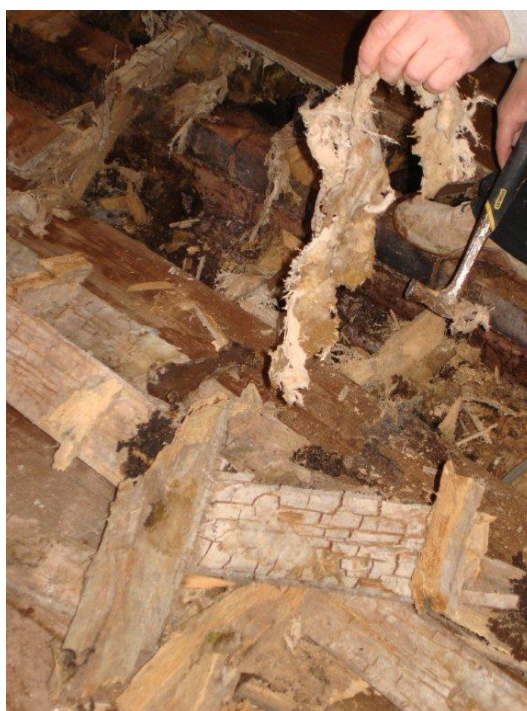
Figure 5

The mycelium develops as thick silver-grey sheets or skins as shown here, usually showing patches of lemon yellow or tinges of lilac. In damper or darker locations, it may appear as soft white cushions with cotton wool appearance. Note the cuboidal cracking of infected timber in the lower section of the photograph.

The overall mass of the hyphae is known as the mycelium. It can appear as fluffy white growths resembling cotton wool. It can also present itself in sheets or skins of grey or white matted material (appendix figure 5). The mycelium can also often have tinges of lilac or patches of lemon-yellow colouring.

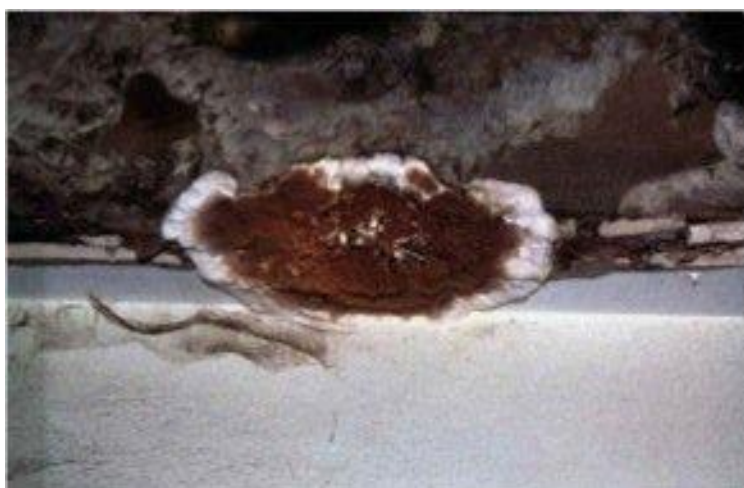
Figure 6

Fruiting bodies are fleshy and soft shaped like pancakes or brackets. When they are ready to fruit, they bear masses of tiny rusty red spores which settle on surfaces with the appearance of rust-coloured dust.

When well established and other conditions are suitable its flowers by producing fruiting bodies. These are fleshy plate-like brackets or pancakes, similar in appearance to those seen on trees in woodland. They develop a series of shallow folds, which bear the seeds or spores. The centre becomes rusty red as the spores develop (appendix figure 6).

- Fruiting bodies appear growing through plaster, in corners, on timber surfaces, or from behind timber surfaces (appendix figure 6). They can also form in masonry joints or voids, internal and external.
